Lessons Learnt - Overflow of LNG from the LNG Cargo Tank Mast

Analysis of an LNG carrier release in 2015

GIIGNL Technical Study Group report

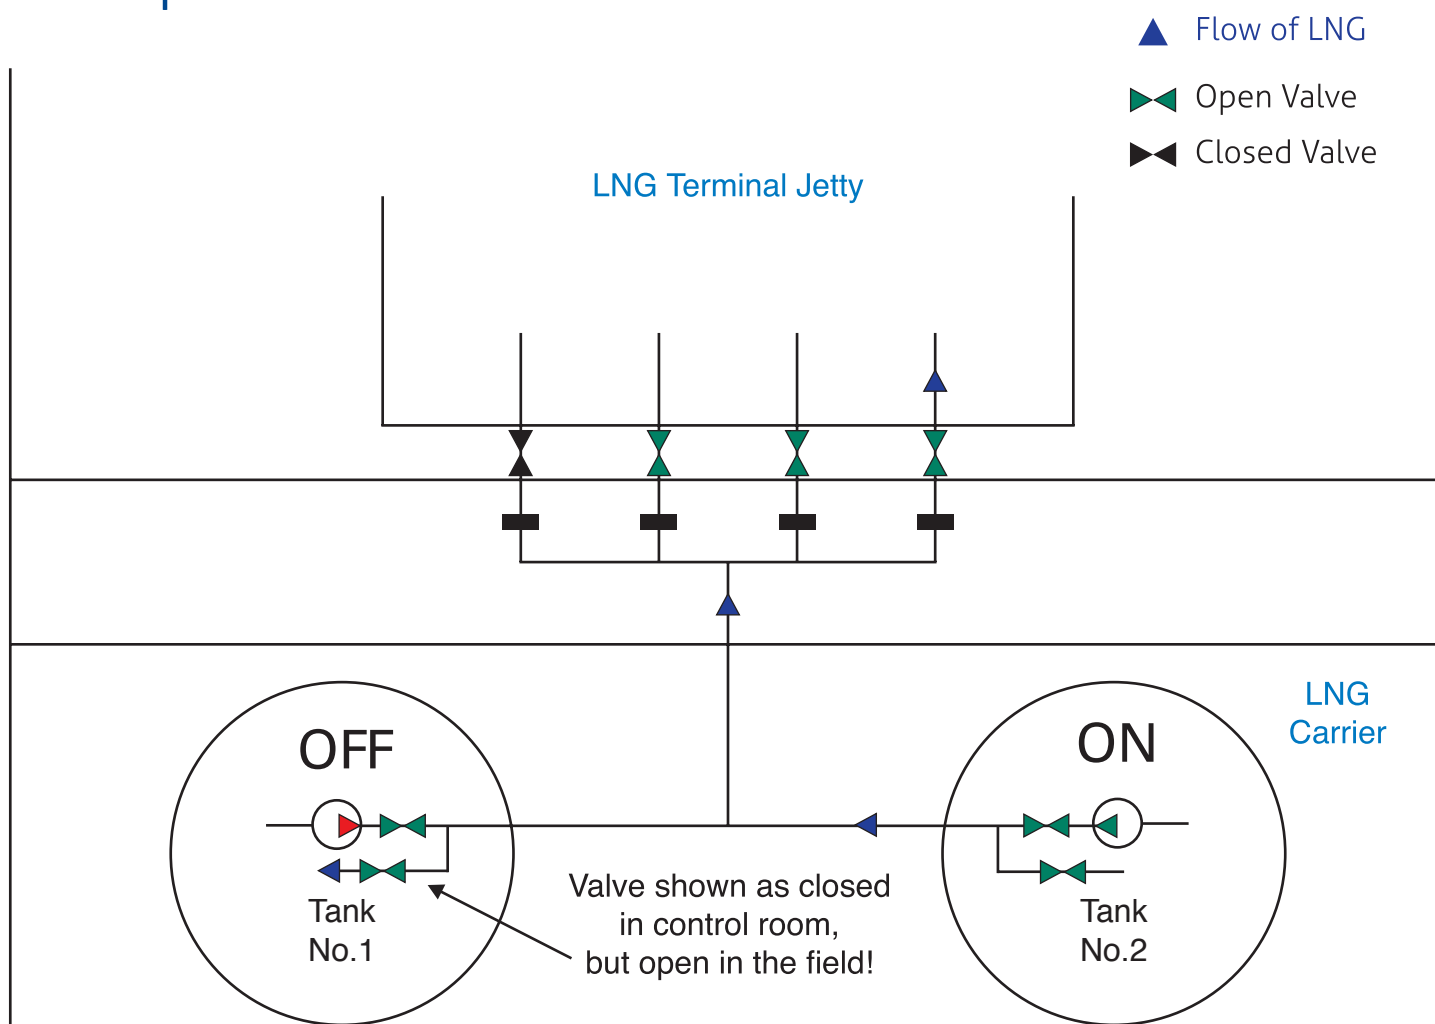
Figure 1 - Illustration of Line out Configuration

Separately, the No.1 Tank filling valve had been directed to close, but had not closed fully due to a failure in the valve positioner resulting from corrosion caused by moisture. The valve status showed as 'closed' in the LNGC's control

room. The failure to isolate the No.1 Tank created a route for LNG to enter the tank when discharge from the No.2 tank commenced.
